SUSQUEHANNA RIVER BASIN
LEGGETTS CREEK, LACKAWANNA COUNTY

GRIFFIN DAM
NDS ID NO. 188
PENNSYLVANIA GAS AND WATER COMPANY

PHASE I INSPECTION REPORT
NATIONAL DAM INSPECTION PROGRAM

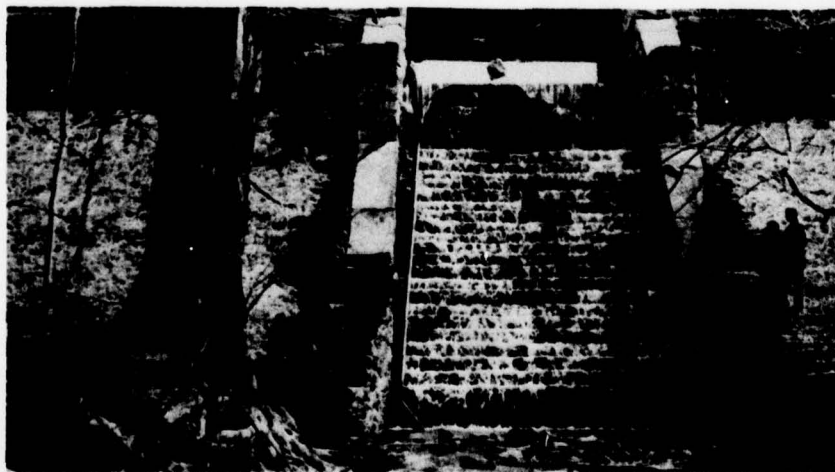
(2) Downstream of the stepped cascade, mortar has deteriorated over the upper half of the masonry spillway walls. The small auxiliary dry masonry wall on the right side of the spillway has tilted backwards (Photograph D). It makes an angle of about 45° with the vertical. This wall has a maximum height of about 2 feet. There are signs of erosion under the wall. Each masonry block in the right and left spillway training walls, that are located directly above the spillway crest, has a fine diagonal crack about 6 inches long. At the junction of the right spillway approach wall and the intake structure, there appears to be an open joint; this area was not accessible for close inspection. At the junction of the left spillway wall with the masonry gravity structure of the dam, there is seepage through the masonry joints below spillway crest. The masonry blocks in this area were wet, but there was insufficient seepage to cause flowing water.

(4) The operation of the 8-inch diameter siphon was not observed (Photograph D). Before operation, the siphon would have to be manually primed by allowing water to enter a plug at the high point of the pipe. Both this plug and the stem to operate the valve, which is at the toe of the spillway cascade, would be submerged during high spillway flows.

(2) The deteriorated mortar in the upper levels of the spillway walls could allow seepage through the open joints and could prevent the structure from acting as a monolith. The erosion under the tilted dry masonry wall at the right side of the spillway could be caused by surface runoff or by water from the spillway splashing up and running under the wall. The fine cracks in the masonry blocks in the walls by the spillway crest could indicate slight movement of the spillway or they could be caused by the natural freezing and thawing of the blocks every winter. Dynamic loads from vehicles crossing the spillway bridge could also cause these cracks. The open joint between the right spillway approach wall and the intake structure could create a shorter seepage path through the dam. Some drawings indicate that some parts of the spillway walls were placed without mortar. Such construction is undesirable.

D. Spillway Looking Upstream

(6) Repair dry masonry wall at right of spillway.
